8 Recommendations

Narryna – Landscape Master Plan.

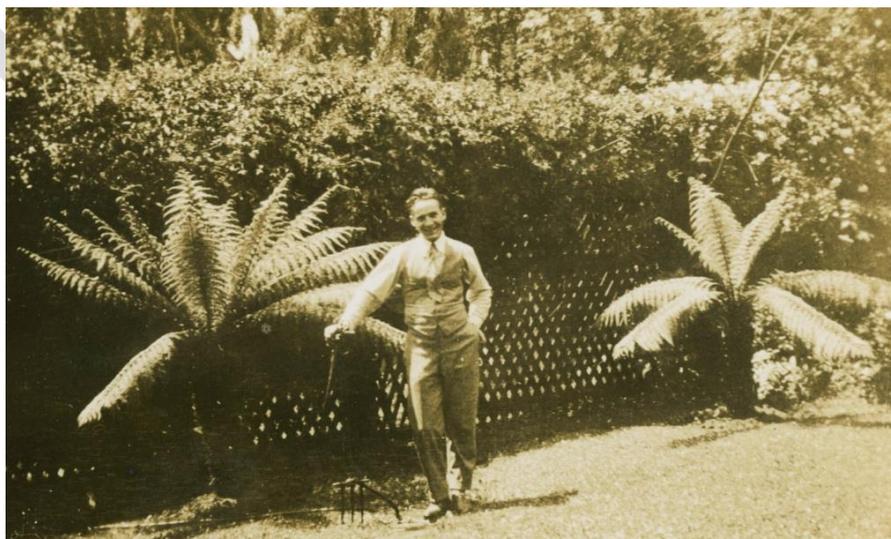
Photo 8a. John Peate in the garden

It is also recommended that in front of the lattice fence separating the front and back gardens two mature tree ferns are planted as seen in the Peate family photo 8a.

Re-establish the two tree ferns planted in front of the lattice fence separating the front and back gardens on the eastern side of the house.

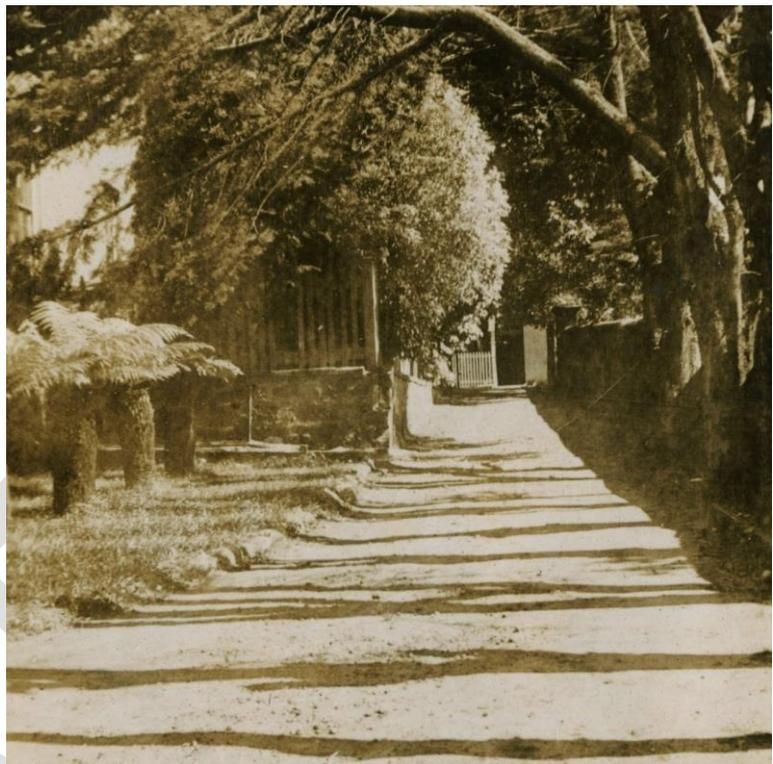
The picket fence to the top of this wall while similar to and replacing an earlier picket fence does not exactly replicate that fence.

Photo 8d. Side Entrance Narryna

It is recommended that when funds permit it should be replaced with a replica of the original.

It is recommended that in the interim the existing gate at the southern end of this fence be replaced with a picket infill to match the existing fence.

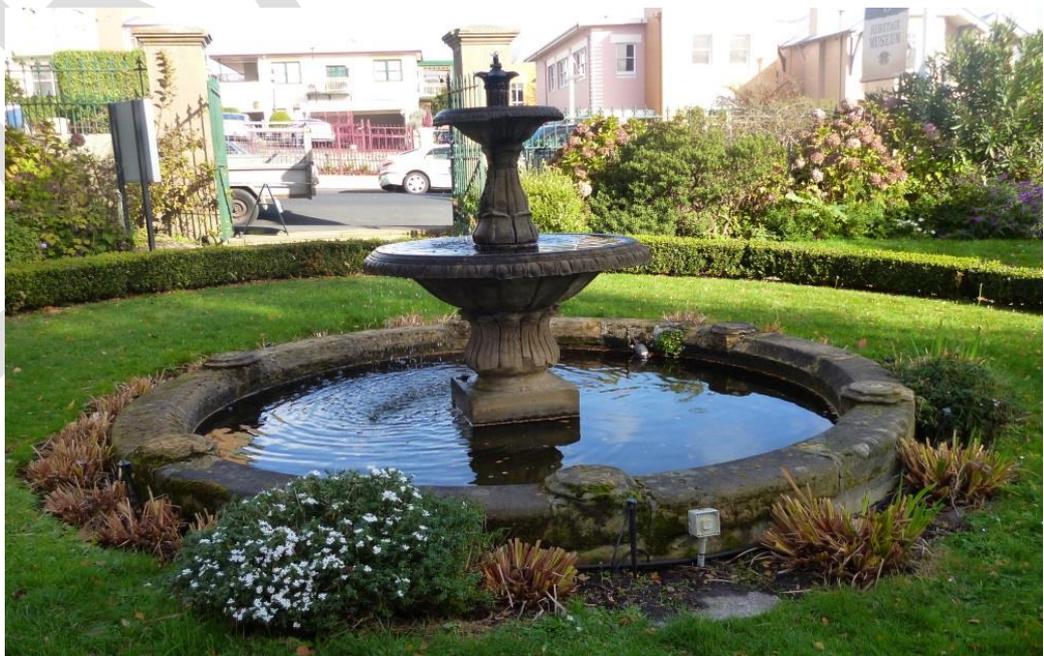
The fountain although not original is an appropriate feature to bring formality to the front garden. There is however a problem with the discharge of water from the fountain bowls. It is therefore recommended that both bowls be re-levelled to give uniform discharge around the perimeter of the bowls. It is recommended that early professional advice on the deterioration of the fountain stonework be obtained.

Photo 8e. The fountain Source: Cripps collection

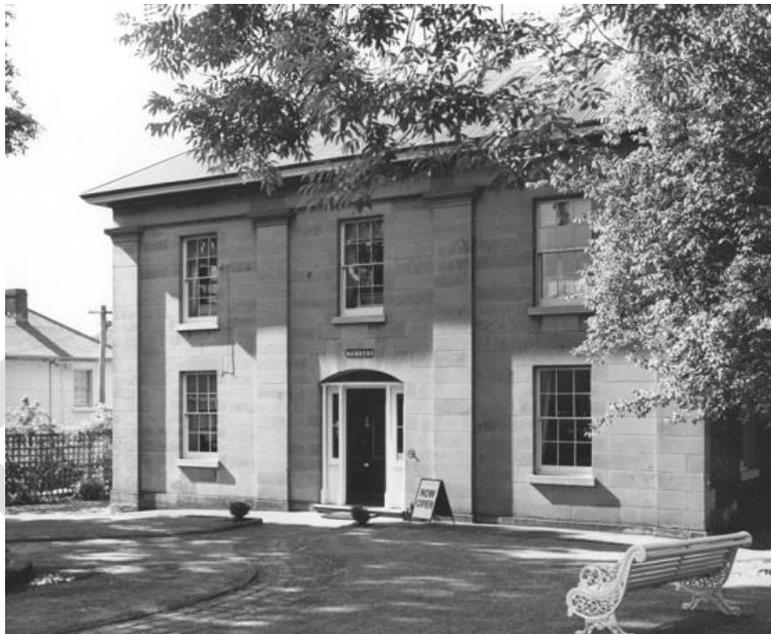
At present the seats are painted green, but in early photos they are white.

Photo 8f1. Garden seat – white.

It is recommended that following paint scrapes, they be repainted to their original colour.

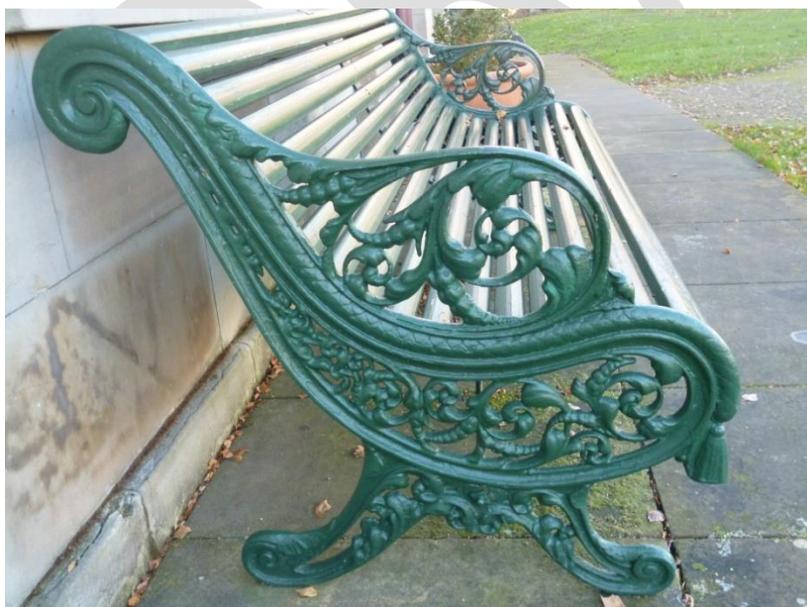
Photo 8f2. Garden seat - green.

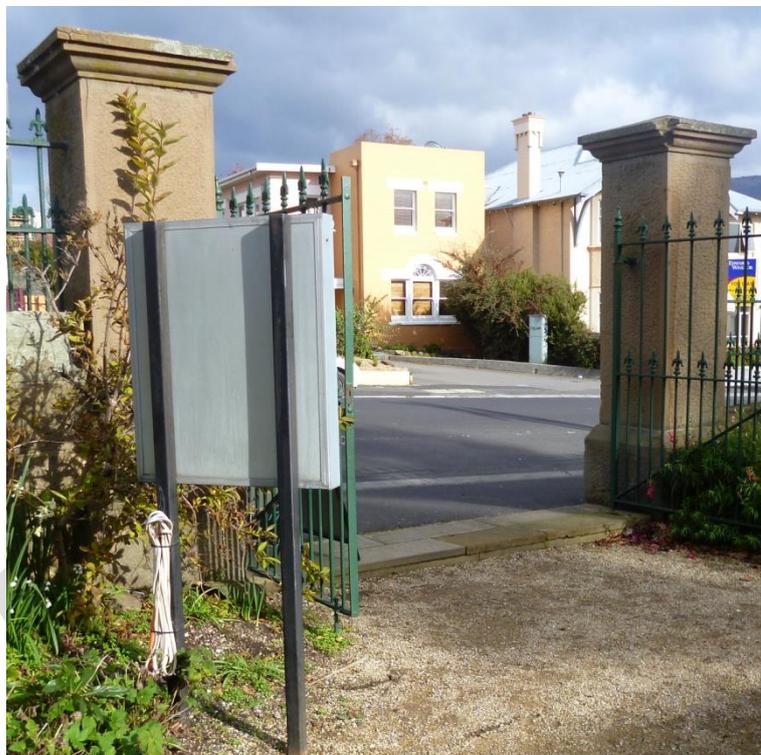
A number of the signs are poorly designed and in need of maintenance.

For example the sign at the front entrance has unfinished electrical cabling taped to the back which presents an unsightly appearance to visitors.

Photo 8i. The front entrance sign.

There needs to be a signage and interpretation plan incorporating policy and recommendations. It should include:
